PacPines Pool's

- Swimming Pools

CASE STUDY - SWIMMING POOL

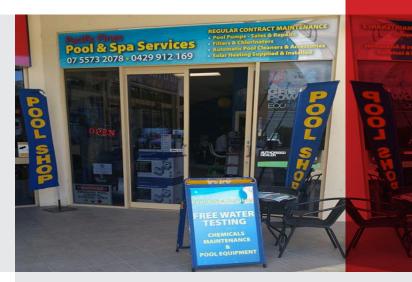
- Swimming Pool Enclosure:
 - $-29m \times 10m = 290m^{2}$.
 - 2.5m to 9m to 5m pitched ceiling.
- Airius solution:
 - 5 x Model 15's.
 - 3 x Model 45-PS/4's.
- All condensation problems rectified.
- Condensation virtually eliminated.
- Comfort effects felt immediately.
- Simple, quick & cheap installation.

The trial pool enclosure was 29 metres long by 10 metres wide. It had a pitched roof rising from 2.5 metres to 9 metres, which then dropped to 5 metres.

5 x Model 15 Airius Standard Series and 3 x Model 45 PS 4 Standard Series were specified and installed, as directed in the bespoke system design installation guide supplied by Airius.

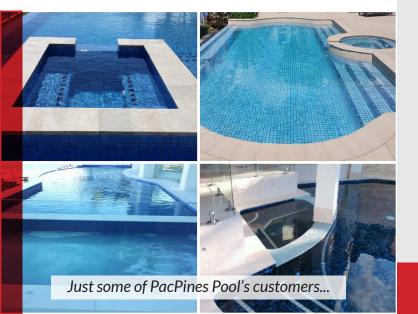
The almost silent Airius units work by circulating the air around the space offering air movement, which increases the 'dew point' and draws moisture from the surfaces into the air. A simple and inexpensive solution to a typical and costly indoor pool issue.
